Important warranty information concerning astronomical devices

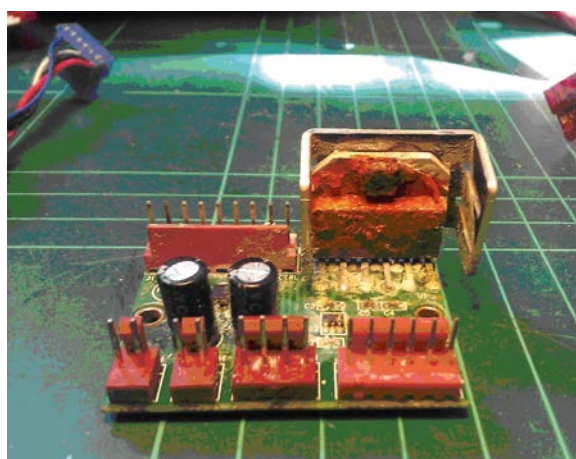
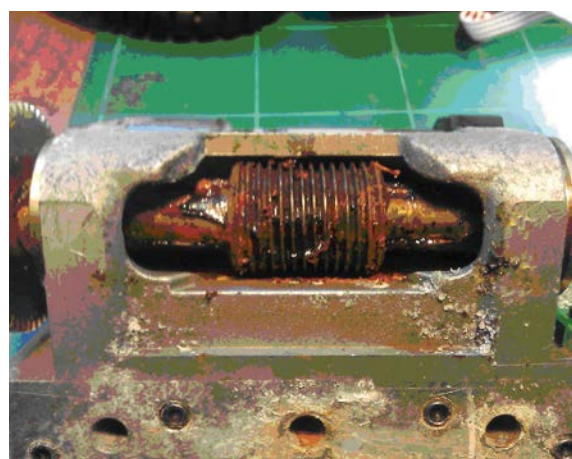
In normal use, nothing happens to a mount even in humid nights - but if it is virtually standing in water as shown here, damage will occur that is not covered by our warranty. Always store dry when not in use - whether in the home or protected in a climate-controlled dome.

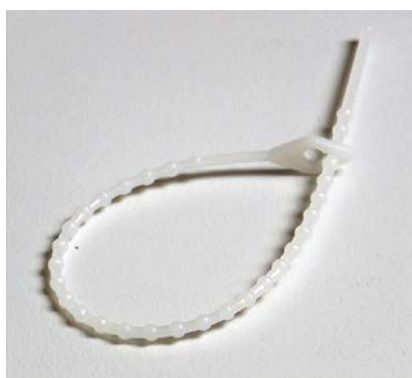
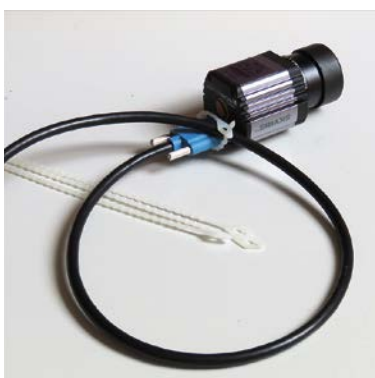
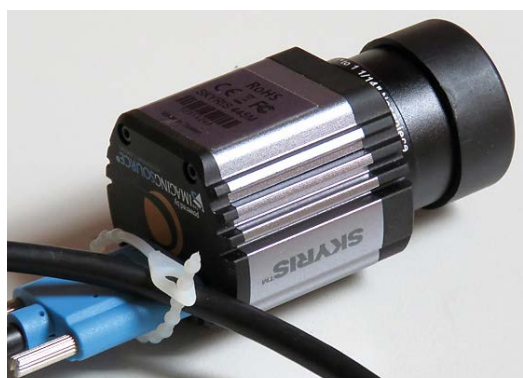
Figure 01: Re-open cable tie (knot ribbon). Figure 02 and 03: Cable loop directly to the USB 3.0 connector of SkyRis camera with tape knot to secure

Insert cable plugs into the lead in loops and secure the loop with a cable tie (Fig. 02 and 03 below). To prevent by bending the cable directly at the plug cable breaks and at the now so filigree connectors such as USB 3.0 on video modules or RJ 11 connectors for car or Selfguiding ports damage to the connectors. In „bulky, hard“ cables (cold temperatures, see Fig. On the right), it is often sufficient, the cable through a loop, for example, supply via a clamping screw or driving the focuser the corresponding port on the mount or the camera.

Work portable, use cable ties which can be opened again (Fig. 01). They are found on the Internet – for example, Conrad Electronics – under the search term „Node Chains“, see also here:

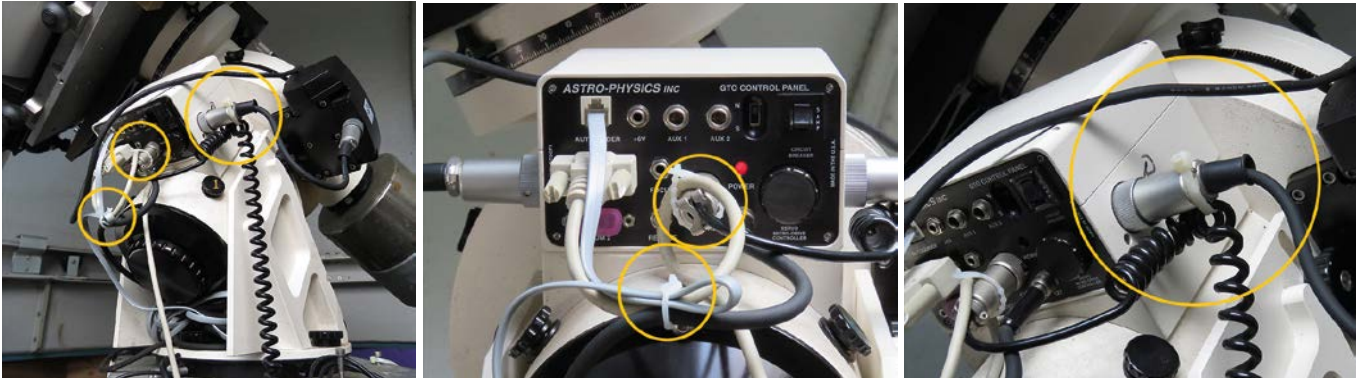
Overview of Astrophysics GTO 1200th

From left to right: merged cable RS 232, Guiding and voltage supply of the GTO, intercepted cable on manual control connector and strain relief spiral cable remote control to the motor plug RA.

Picture center: Detail view of the merged cable RS 232, Guiding and Soannungsversorgung mount and strain relief connector on the manual control unit.

Right: Detail view of the strain relief of very severe Spira cable hand control unit Mount the plug of the RA motor cable.

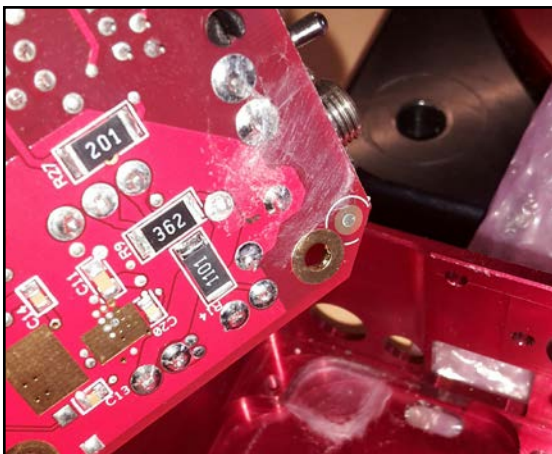
Toasted Spider on Paramount ME Board

This was the reason for a broken mainboard of a telescope mount. An insectproof housing is a good investment for a permanently mounted telescope.

The web is directly besides the power socket, but on the backside of the board. The spider could not be seen, perhaps it crawled into the socket and was toasted there. You can even see how the edge of the board was covered with the web.

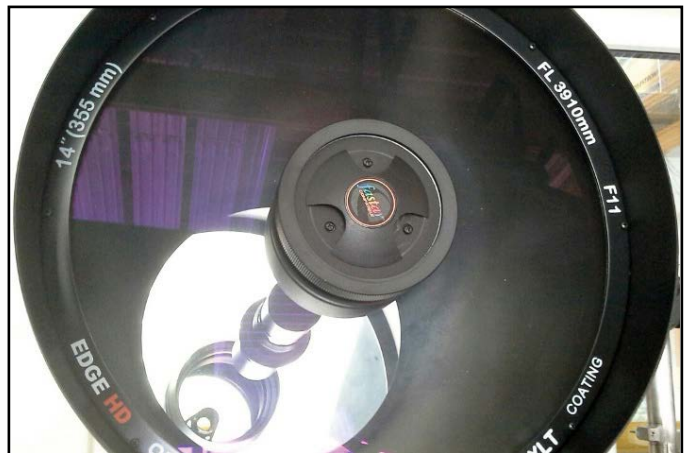
C14 EdgeHD with fogged Schmidt plate (in the right third, diagonal)

Occasionally customers complain especially Schmidt Cassegrain optics, because the Schmidt plate and / or the primary mirror inside „fogged“, and this fog does not disappear. Except for a few cases, these are the residues of condensed humidity, which has passed through unfavorable weather conditions and incorrect handling of the optics in the tube.

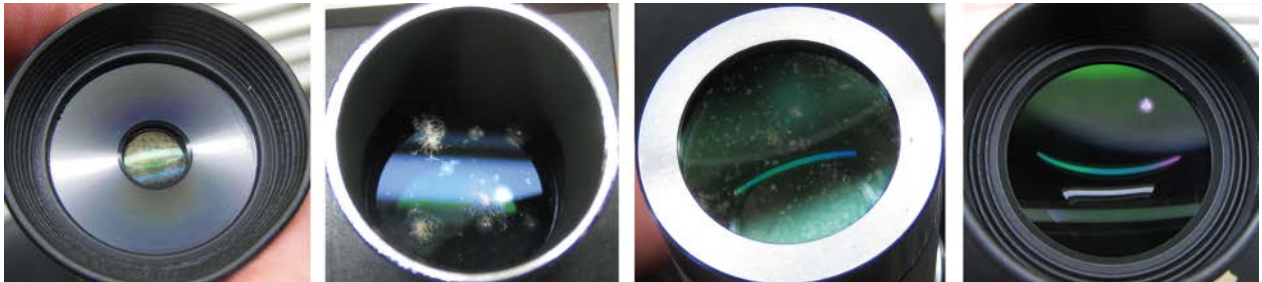
These eyepieces are infected by lens fungus. The ocular on the left is fully overgrown, the right ocular is only little infected.

fect climate for mould and fungus to thrive. Lens fungus is an umbrella term for a whole range of mould or fungi that feed on substances used in making lenses or deposited on the lens as dirt. They can damage coating and glass – keep your telescope therefore in the dark, dry, not too warm and well ventilated to avoid mould. Fungi are very resistant and almost impossible to eliminate; fungus spores have even survived a vacuum. Damage to coating or glass by fungus infestation cannot be remedied and is not covered by our warranty.

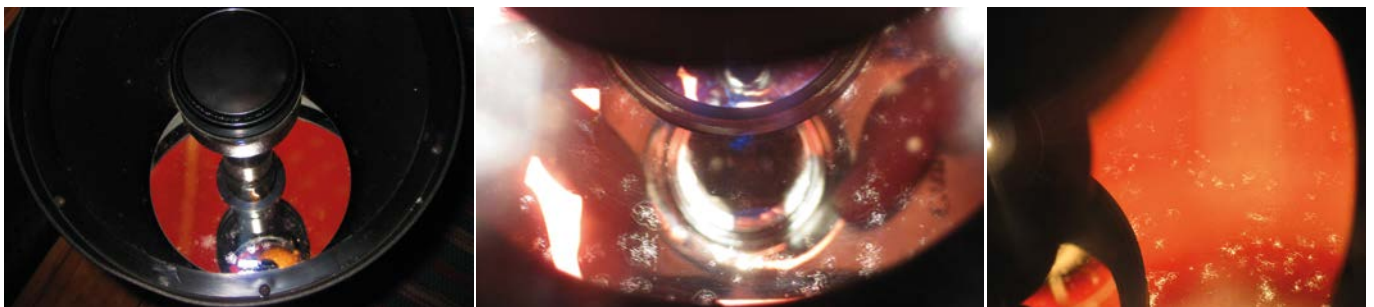
These images show the view into a Schmidt-Cassegrain, which was stored at moist-warm climate near the ocean for some years. Even the closed tube of a SC was no protection against fungus under this conditions.
